Llannerch Bridge Newsletter

How and why the bridge collapsed

Jim Hall, the Council's senior bridge engineer, has provided the following explanation for how and why Llannerch Bridge collapsed:

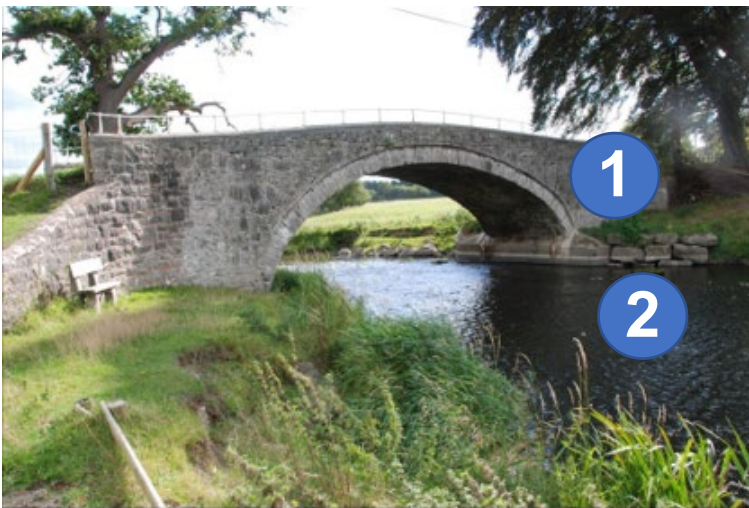
Figure 1 (above) - Photograph of Llannerch Bridge prior to collapse

1. Evidence of a flattened arch on the Trefnant side of the bridge. This means the abutment (supporting structure the bridge sits on) has likely moved since the bridge was first built. Arch bridges rely on compression forces squeezing the rocks together to enable the bridge to carry its own weight, and that of the traffic that crosses it. A flattened arch means that the ability to carry compressive loads will be reduced.

2. Evidence of scour (removal of river sediment around the abutments) under the bridge. The depth of the river 50 metres either side of the bridge allows for the bridge to be crossed in Wellington boots most of the year. Under the bridge, the river depth was recorded between 2.5 metres and 4 metres deep. A recent scour assessment suggested that the theoretical scour depth (the amount of material that can be washed away before the river is running over bedrock) is 9.5 metres. If this was to happen then any new bridge foundations would be under severe stress.

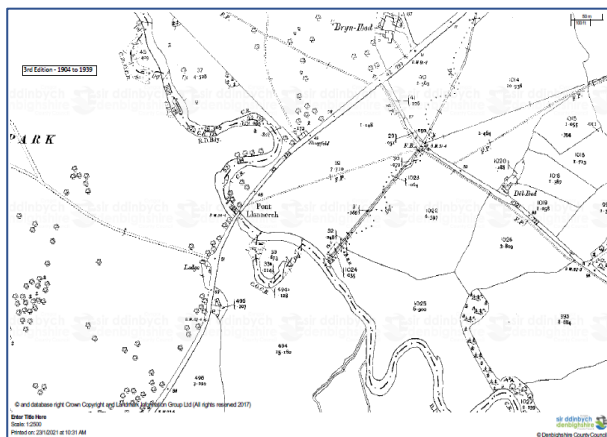
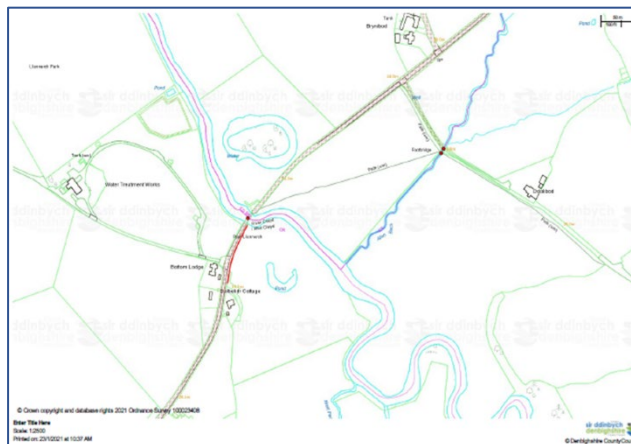
Figure 2 (below left) - Map showing river Clwyd between 1904-1939

It is possible to see that even within the last century the flow of the River Clwyd has changed significantly. The meanders are highly active, with the meander downstream of Llannerch bridge having been lost, whilst the meander upstream has moved up to the road.

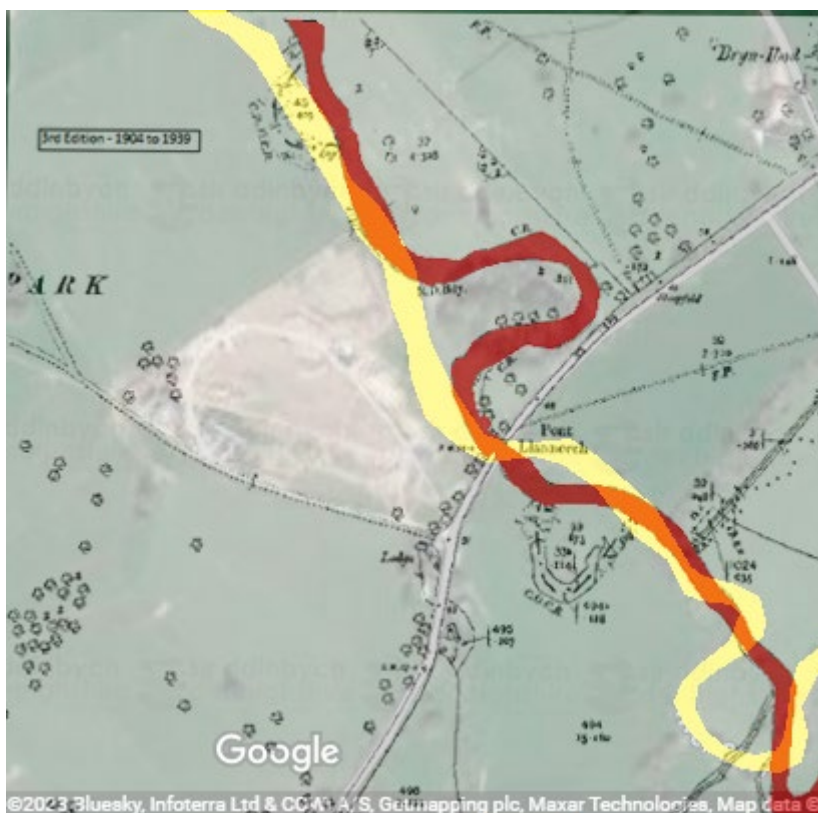
Figure 4 (above) - overlay of pre-WWII map (red) against a recent Google Earth satellite image (yellow)

We have highlighted this on the left by overlaying the pre-WWII map (with the river highlighted in red) against a Google Earth satellite image taken in April 2015 (with the river highlighted in yellow).

This change to the river flow will affect how water interacts with the bridge structure, and – as explained, has impacted the scour and potentially undermined the bridge foundations.

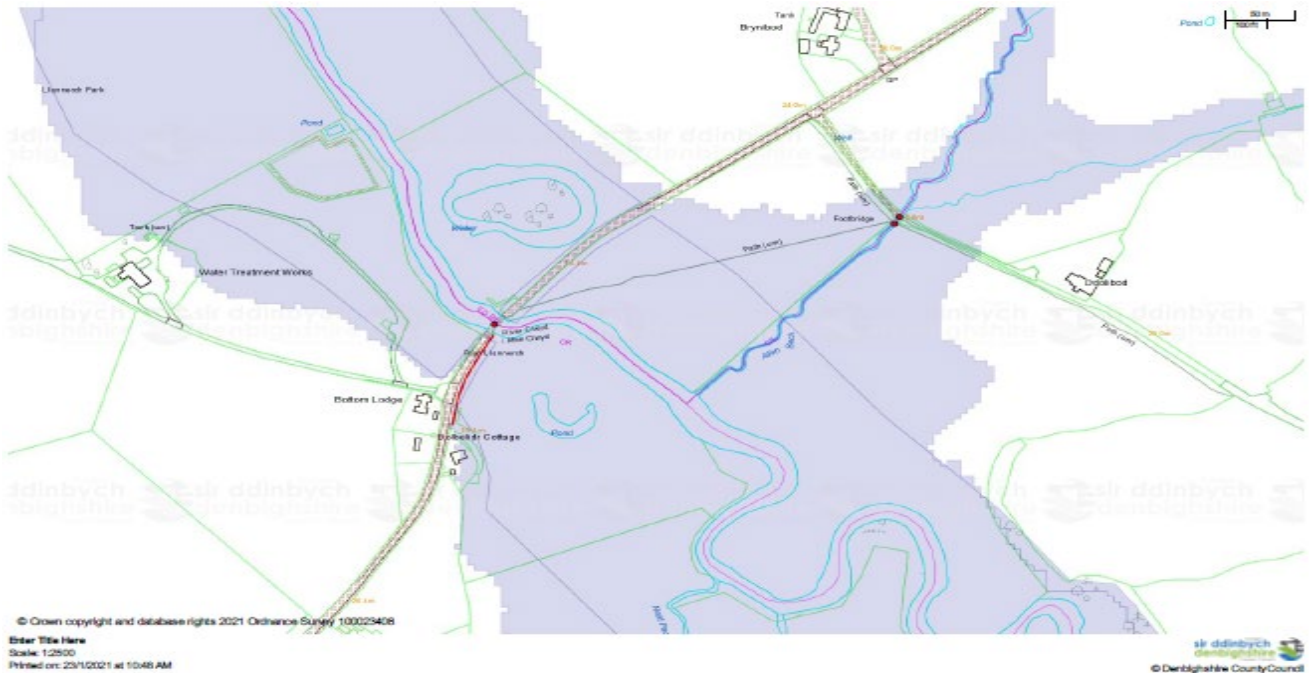
Figure 5 (above) - map showing the current flood plain for the River Clwyd

The flood plain for the River Clwyd is significant. However, because the road is raised, all water from the river must pass through the bridge hole until the water level reaches significant height to flood the road. This is visible in the overhead image shown here, as much of the ground that theoretically belongs to the flood plain

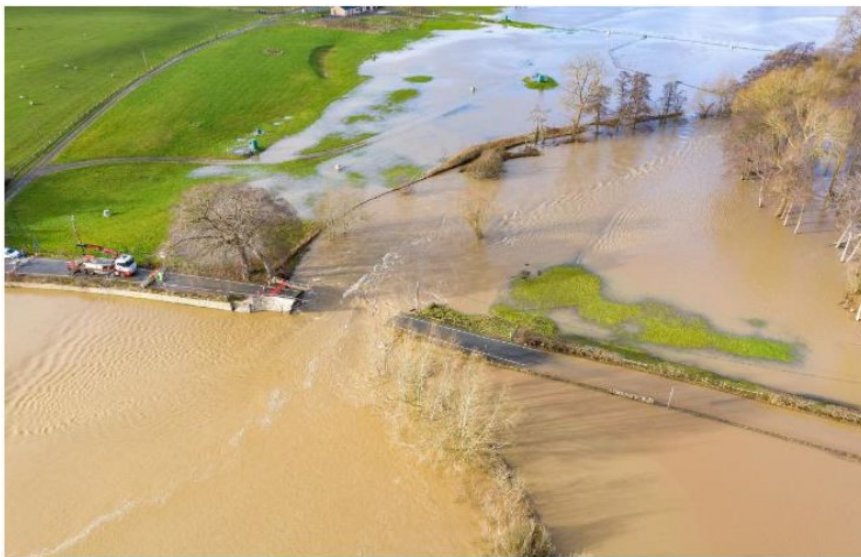
Figure 6 (above) showing the impact of the raised road on the flood plain

In Denbighshire, the Llanerch Bridge between Trefnant and Tremeirchion collapsed
CHRISTOPHER FURLONG/GETTY IMAGES

downriver of the bridge, remains dry. It is also possible to see the velocity (speed) and force with which the water is flowing through the gap where the bridge once stood.

A rising or lowering flood is a problem because the velocity (speed) at which the river passes the road changes dramatically. It also changes dramatically at various depths, hence the flows of water can become very complex.

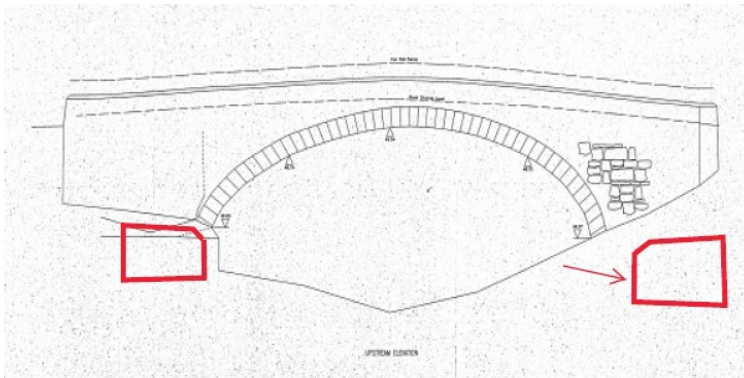
Figure 7 (above) - diagram showing the span of Llannerch Bridge with the springing highlighted in red

The tree was sited upstream of the bridge, on the Tremeirchion side, behind the 'springing' element of the bridge.

The springing is the part of the bridge that separates the arch of the bridge from the bridge foundation. This passes forces

from the arch down into the ground, but also keeps the arch under compression by the sheer weight of material behind the springing, pushing back *up* on the arch.

When the tree fell, flood water rushed into the space where the tree's root ball had been, and quickly eroded the softer ground material behind the tree root. With no material behind the springing element, the weight of the arch would have pushed the springing away from the bridge, and the arch then collapsed, filling the once-deep scour hole in the river. The abutment structure then rolled on top, pinning it in place.

In summary, then, a number of factors led to a possible weakening of the structure, and the loss of the tree meant that the bridge lost compression and suffered a catastrophic failure.
